FTI Fasad Teknoloji Merkezi / Façade Testing Institute

DENEY SERTIFIKASI / Test Certificate

Numunenin Adı ve Tarifi / Sample's Name & Description: FS 50 Stick System

Uygulanan Normlar / Norms Applied: TS EN 12153, TS EN 12155 and TS EN 12179

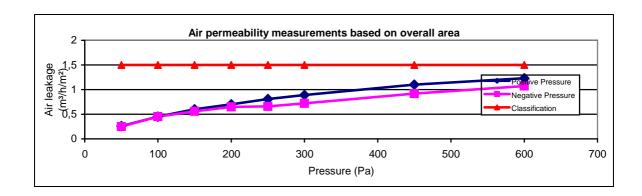
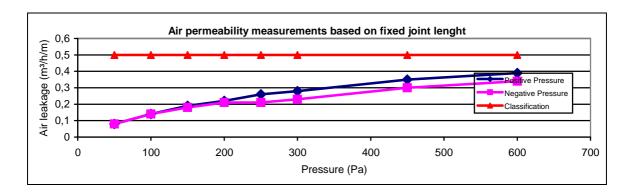
Test No: 2014.307.04 / 24.04.2014

POSITIVE PRESSURE			
φ1 / φ2 Pipe	Test Pressure (Pa)	Air Leakage (m³/h)	Air Leakage (m³/h/m²)
φ1	50	6,39	0,26
φ1	100	11,26	0,45
φ1	150	14,80	0,60
φ1	200	17,49	0,70
φ1	250	20,10	0,81
φ1	300	22,08	0,89
φ1	450	27,38	1,10
φ1	600	30,49	<mark>1,23</mark>

NEGATIVE PRESSURE			
φ1 / φ2 Pipe	Test Pressure (Pa)	Air Leakage (m³/h)	Air Leakage (m³/h/m²)
φ1	50	6,26	0,25
φ1	100	11,13	0,45
φ1	150	13,90	0,56
φ1	200	16,04	0,65
φ1	250	16,31	0,66
φ1	300	17,97	0,72
φ1	450	23,22	0,92
φ1	600	26,69	<mark>1,07</mark>

POSITIVE PRESSURE				
φ1 / φ2 Pipe	Test Pressure (Pa)	Air Leakage (m³/h)	Air Leakage (m³/h/m)		
φ1	50	6,39	0,08		
φ1	100	11,26	0,14		
φ1	150	14,80	0,19		
φ1	200	17,49	0,22		
φ1	250	20,10	0,26		
φ1	300	22,08	0,28		
φ1	450	27,38	0,35		
φ1	600	30,49	0,39

NEGATIVE PRESSURE			
φ1 / φ2 Pipe	Test Pressure (Pa)	Air Leakage (m³/h)	Air Leakage (m³/h/m)	
φ1	50	6,26	0,08	
φ1	100	11,13	0,14	
φ1	150	13,90	0,18	
φ1	200	16,04	0,21	
φ1	250	16,31	0,21	
φ1	300	17,97	0,23	
φ1	450	23,22	0,30	
φ1	600	26,69	<mark>0,34</mark>

CONDITIONS	RESULTS		CLASSIFICATION		
AIR	at 600 Pa ϕ < 1,5 m ³ /h,m ²	Positive Pressure	1,23 0.39	A 4		
PERMEABILITY	at 600 Pa		0,39			
EN 12152	at 600 Pa ϕ < 1,5 m ³ /h,m ²	Negative Pressure	1,07	A 4		
	at 600 Pa		0,34			
WATER- TIGHTNESS (Static Pressure) EN 12154	There should be no water leakage at 600 Pa	No water leakage was observed during the test.		_		R7
RESISTANCE TO WIND LOAD EN 13116	Deflection < 15 mm at +2400 Pa and -2400 Pa	(max. + 4,65 mm) (max 5,74 mm)		ок		
Cycle Test	There should be no damage during 50 cycles at <u>+</u> 1200 Pa	No damage was observed		ок		
WATER- TIGHTNESS (Static Pressure) EN 12154 (Repeat)	There should be no water leakage at 600 Pa	No water leakage was observed during the test.		R7		
RESISTANCE TO SAFETY LOAD EN 13116	There should be no damage at + 3600 Pa and - 3600 Pa	No damage was observed at +3600 Pa and -3600 Pa		ок

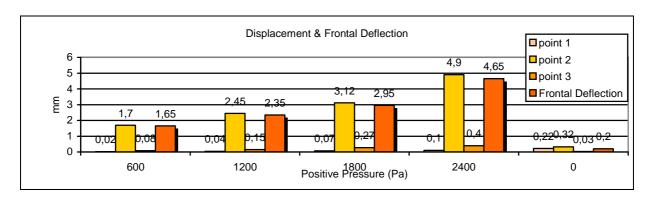
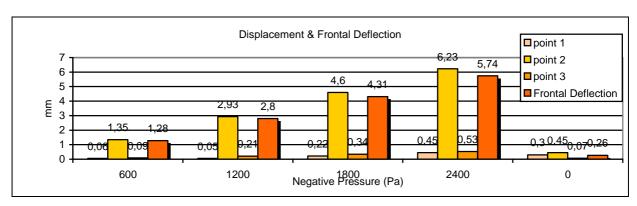
Frontal deflection measurement results on the vertical mullion;

Positive Pressure (Pa)	Point 1 (mm)	Point 2 (mm)	Point 3 (mm)	Frontal Deflection (mm)
0	0,00	0,00	0,00	0,00
600	0,02	1,70	0,08	1,65
1200	0,04	2,45	0,15	2,35
1800	0,07	3,12	0,27	2,95
2400	0,10	4,90	0,40	<mark>4,65</mark>
0	0,22	0,32	0,03	0,20

Negative Pressure (Pa)	Point 1 (mm)	Point 2 (mm)	Point 3 (mm)	Frontal Deflection (mm)
0	0,00	0,00	0,00	0,00
600	0,06	1,35	0,09	1,28
1200	0,05	2,93	0,21	2,80
1800	0,22	4,60	0,34	4,31
2400	0,45	6,23	0,53	<mark>5,74</mark>
0	0,30	0,45	0,07	0,26

Wind Resistance: TS EN 13116 - OK at 2400 Pa (+4,65mm<+15mm; -5,74mm<-15mm)

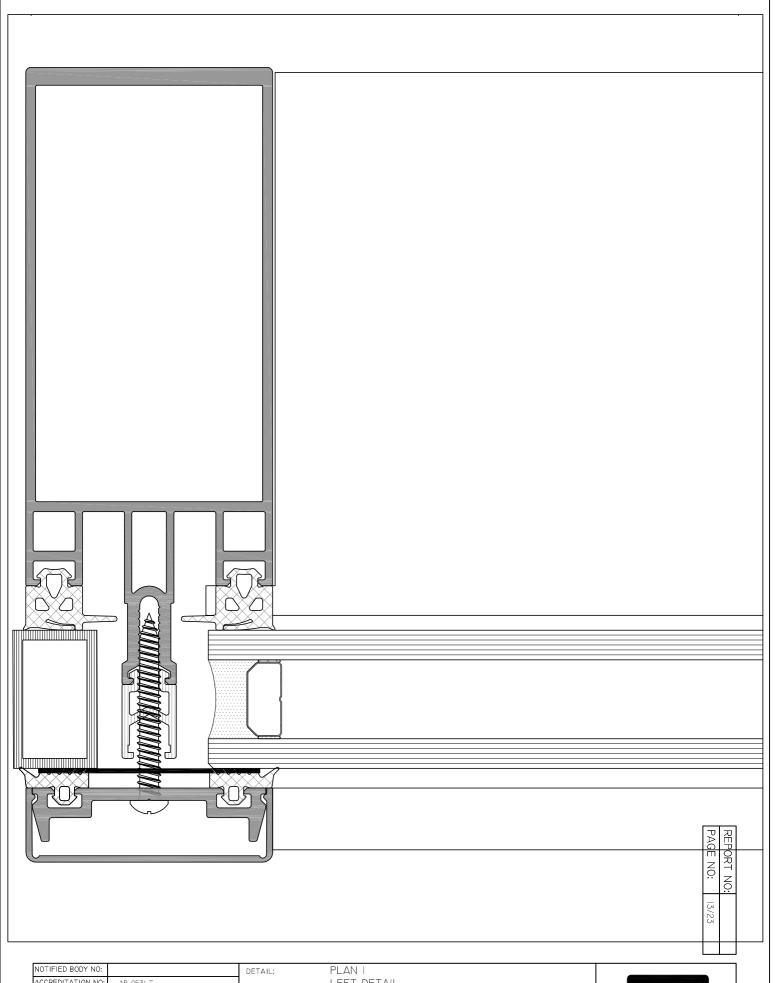
NOTIFIED BODY NO:		DETAIL:	PLAN I		
ACCREDITATION NO:	AB-053I-T]	LEFT DETAIL		
REPORT NO:	010.217.1/2014	PROJECT CODE:	2014.307	DATE:	05.05.2014
PREPARED BY:	S.ÇOLAK	CLIENT:	SARAY DOKUM VE MADENI AKSAM SAN.TUR.A.S.	REV.NO:	А
CONTROL BY:	O.USTA	EXPLANATION:	AIR INFILTRATION, WATERTIGHTNESS AND WIND LOAD TEST

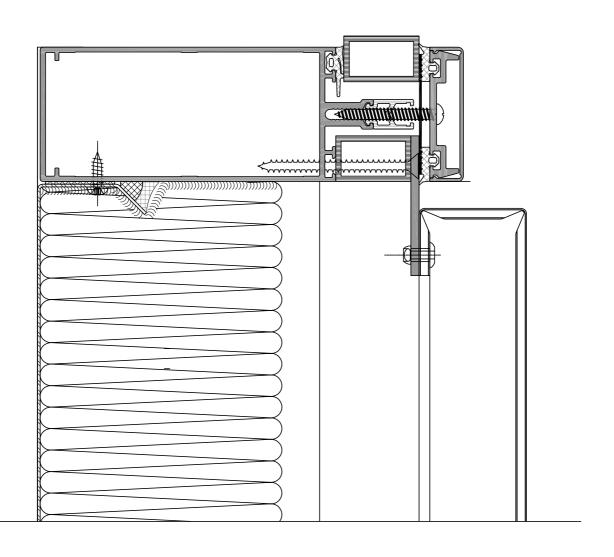
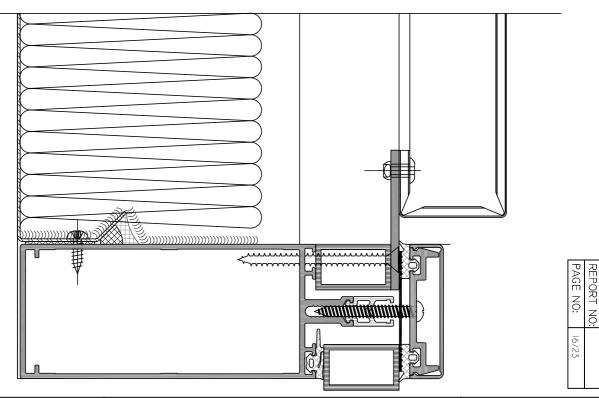
NOTIFIED BODY NO:		DETAIL:	KESIT I			
ACCREDITATION NO:	AB-053I-T	TOP - BOTTOM DETAIL				
REPORT NO:	010.217.1/2014	PROJECT CODE:	2014.307	DATE:	05.05.2014	
PREPARED BY:	S.ÇOLAK	CLIENT:	SARAY DOKUM VE MADENI AKSAM SAN.TUR.A.S.	REV.NO:	А	
CONTROL BY:	0.USTA	EXPLANATION: AIR INFILTRATION, WATERTIGHTNESS AND WIND LOAD TEST

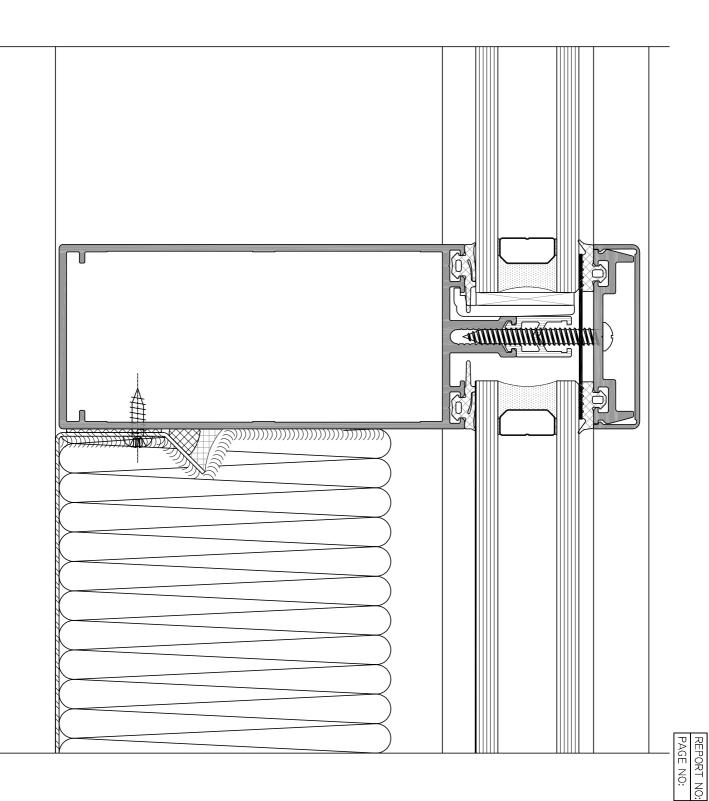
NOTIFIED BODY NO:		DETAIL:	KESIT I		
ACCREDITATION NO:	AB-053I-T	BETWEEN VISION AND SPANDREL DETAIL			
REPORT NO:	010.217.1/2014	PROJECT CODE:	2014.307	DATE:	05.05.2014
PREPARED BY:	S.ÇOLAK	CLIENT:	SARAY DOKUM VE MADENI AKSAM SAN.TUR.A.S.	REV.NO:	А
CONTROL BY:	O.USTA	EXPLANATION:	AIR INFILTRATION, WATERTIGHTNESS AND WIND LOAD TEST
